Wilkes Station Antarctica 1957- 1969

Wilkes Station February 1960 from the Air.

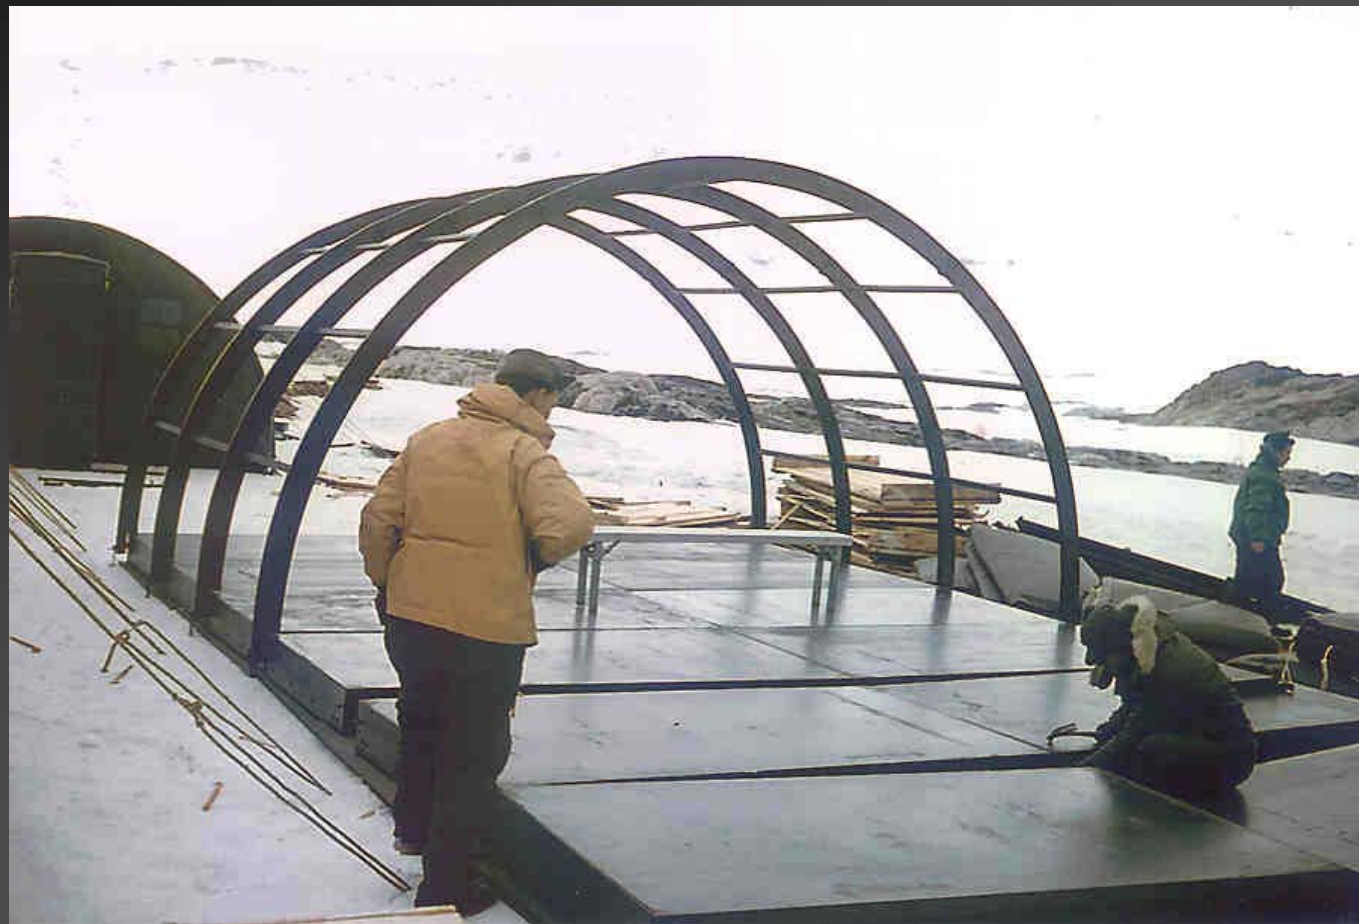
Putting down the foundations. Clements buildings were used by the US for housing the permanent activities of the Station

- Tongue for levelling wall panels
- 100mmthick plywood insulated stress skin panels.
- Floor trusses at 1.2m centres.
- Levelling beam.
- Foundations.

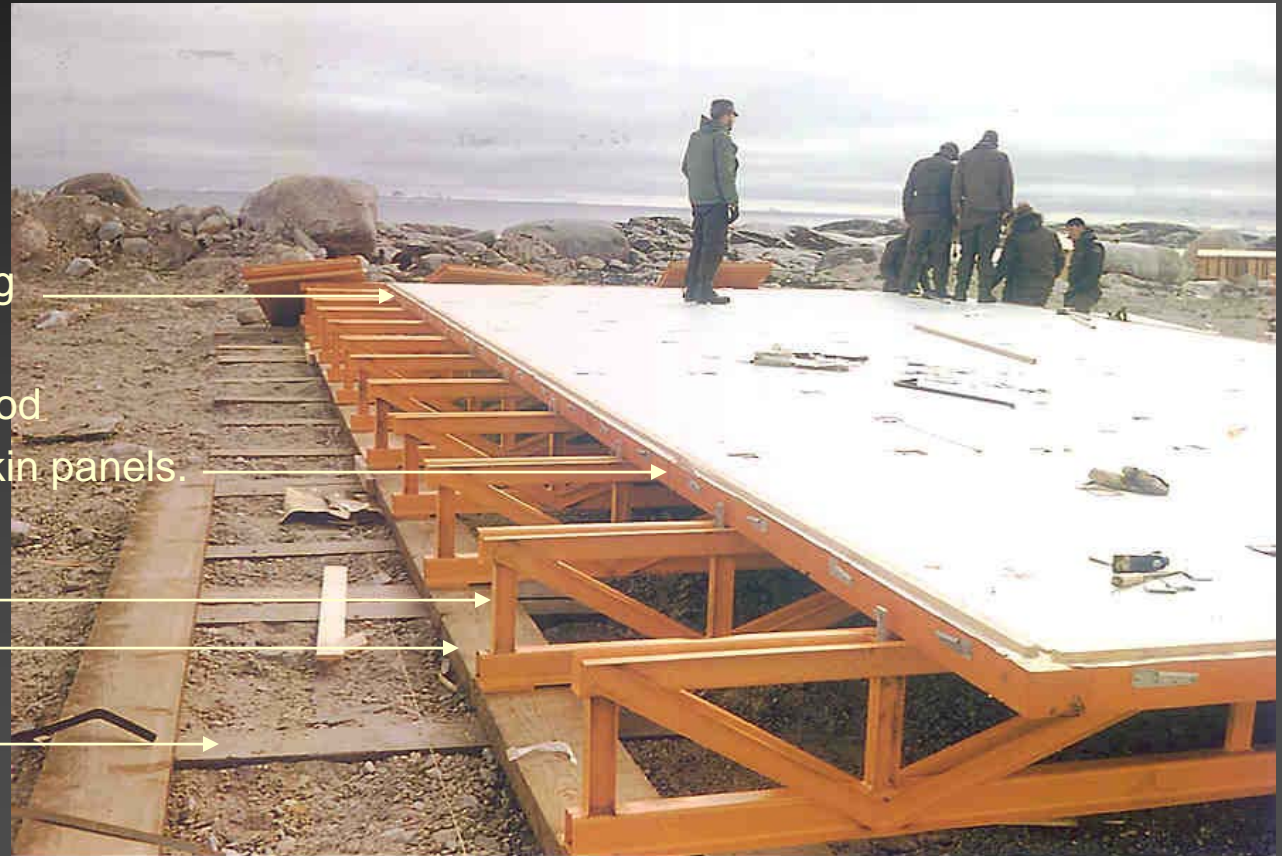
Assembling the Clements prefabricated building system

- Installing the roof panels.
- The wall panels are in place.
- Clements buildings are based on a 4 foot (1.2m) module. The buildings are usually 20 feet (6m) wide and 48 feet (14.4m) or 56 feet (16.8 m) long.

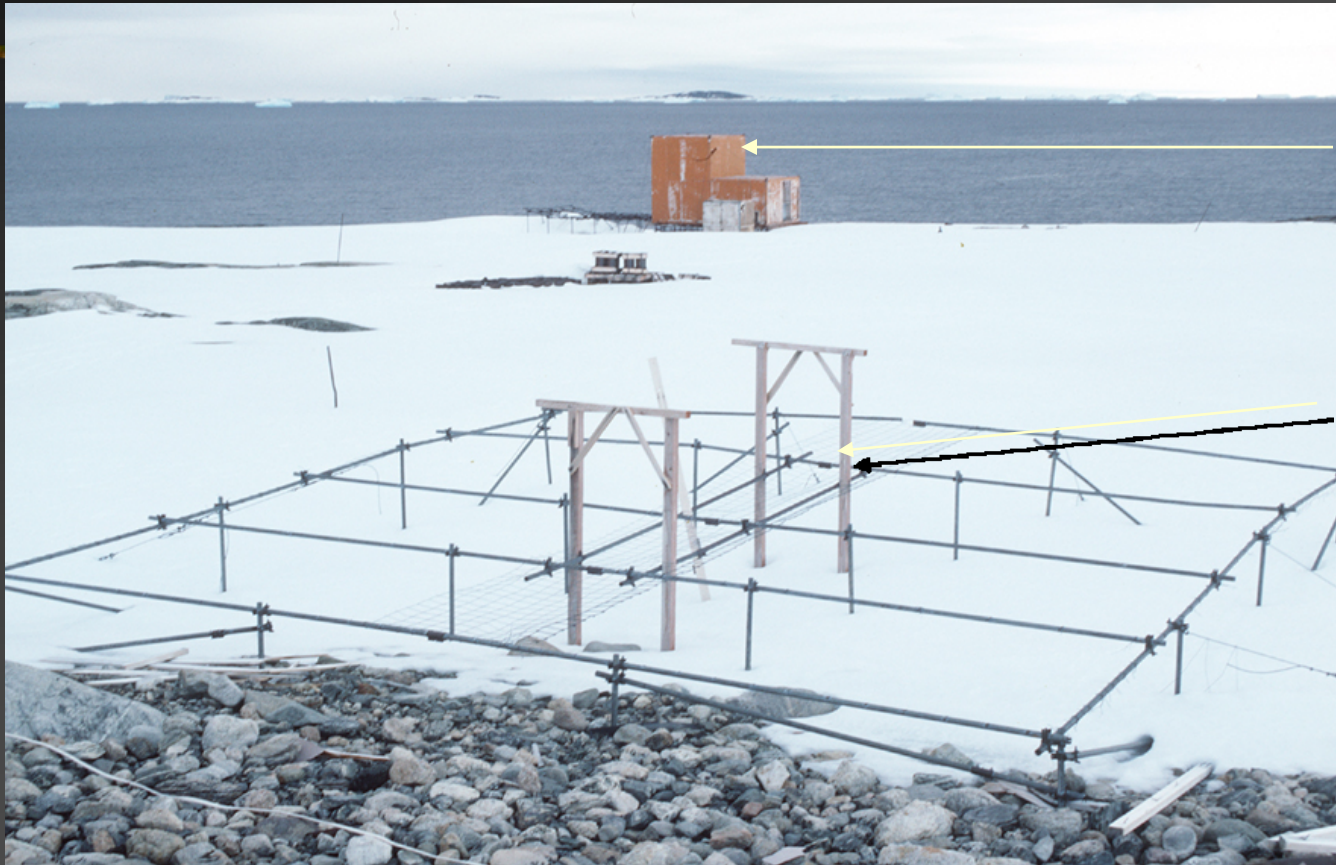
Riometer Frame & Balloon Launching Building

Balloon hut was used twice daily to release meteorological balloons.

Riometer is a Relative Ionospheric Opacity Meter, a crude form of radio telescope that was part of the upper atmospheric research programme in the 1960's.

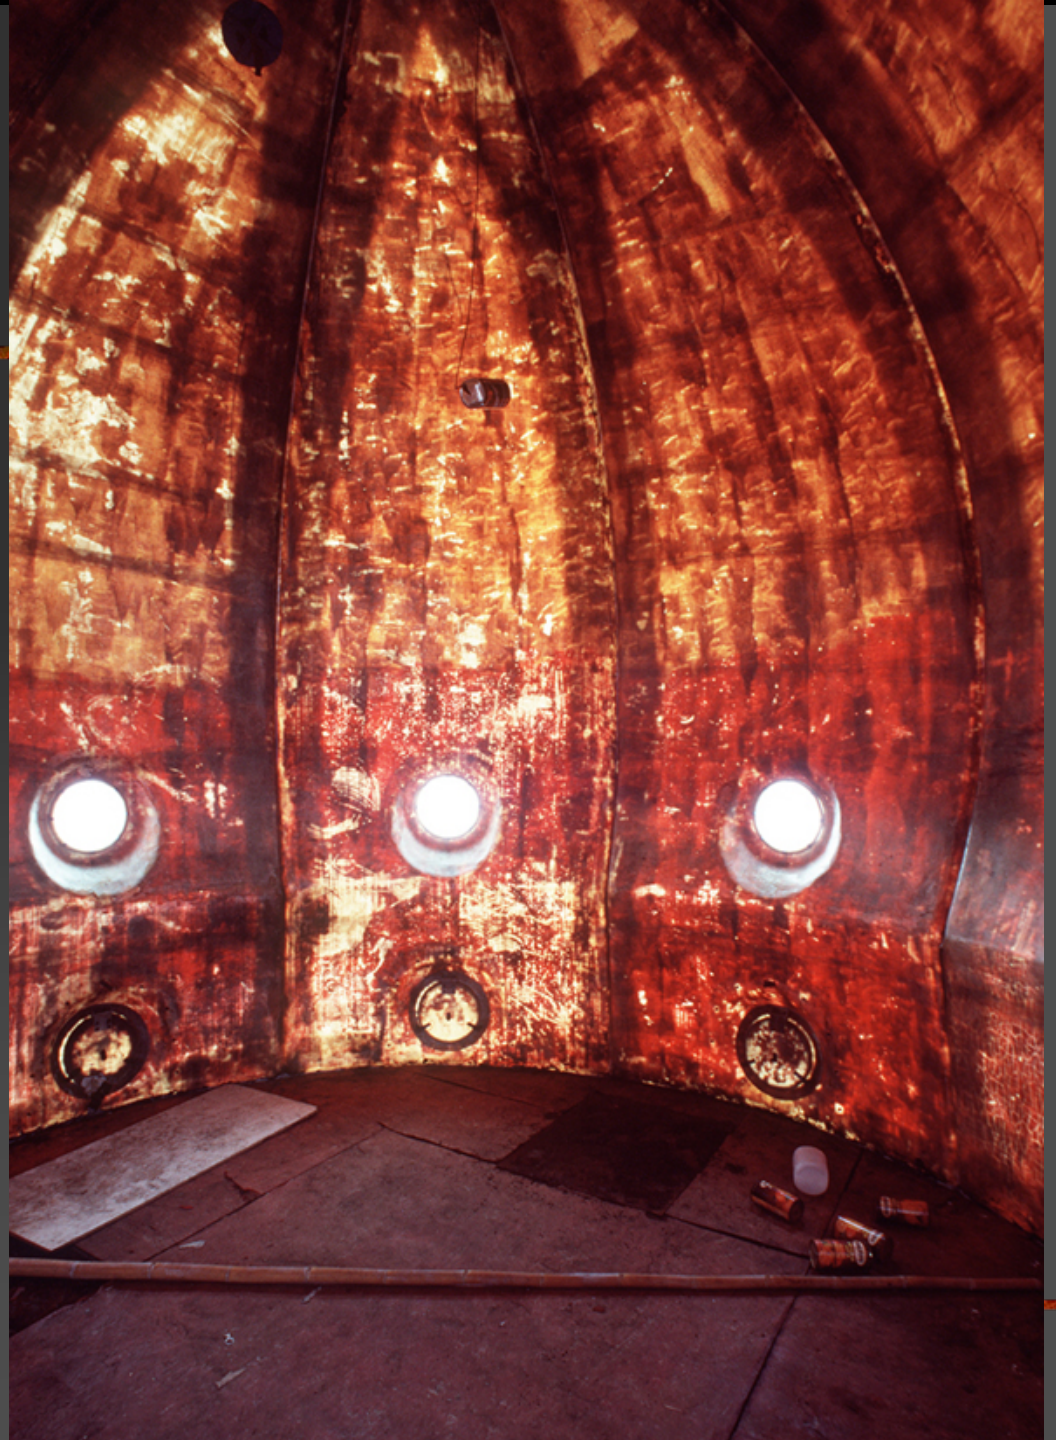
Radar Dome

- The dome housed the radar that manually tracked the radiosonde that was taken aloft by the meteorological balloon.

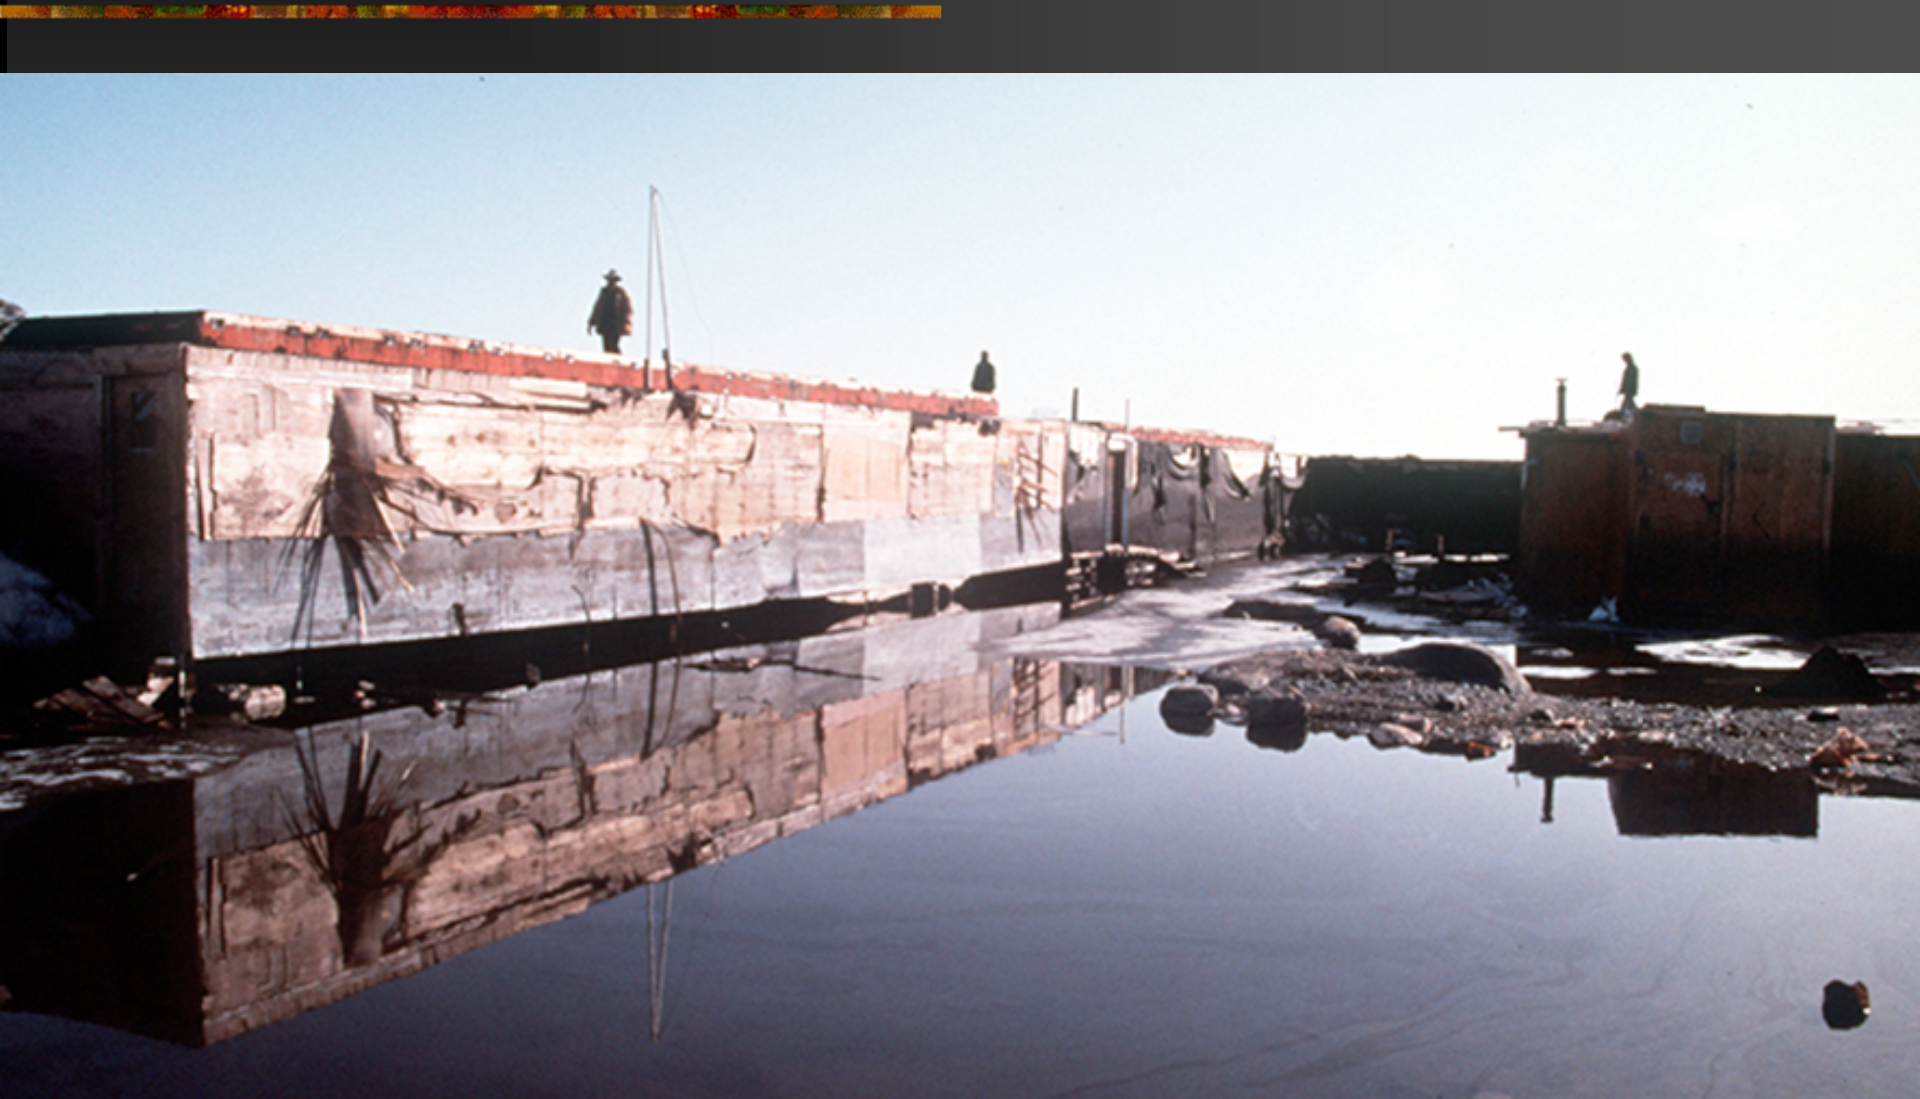
1992 a big melt — this is market square the burlap over the plywood frames used to create enclosed corridors is exposed to the elements.

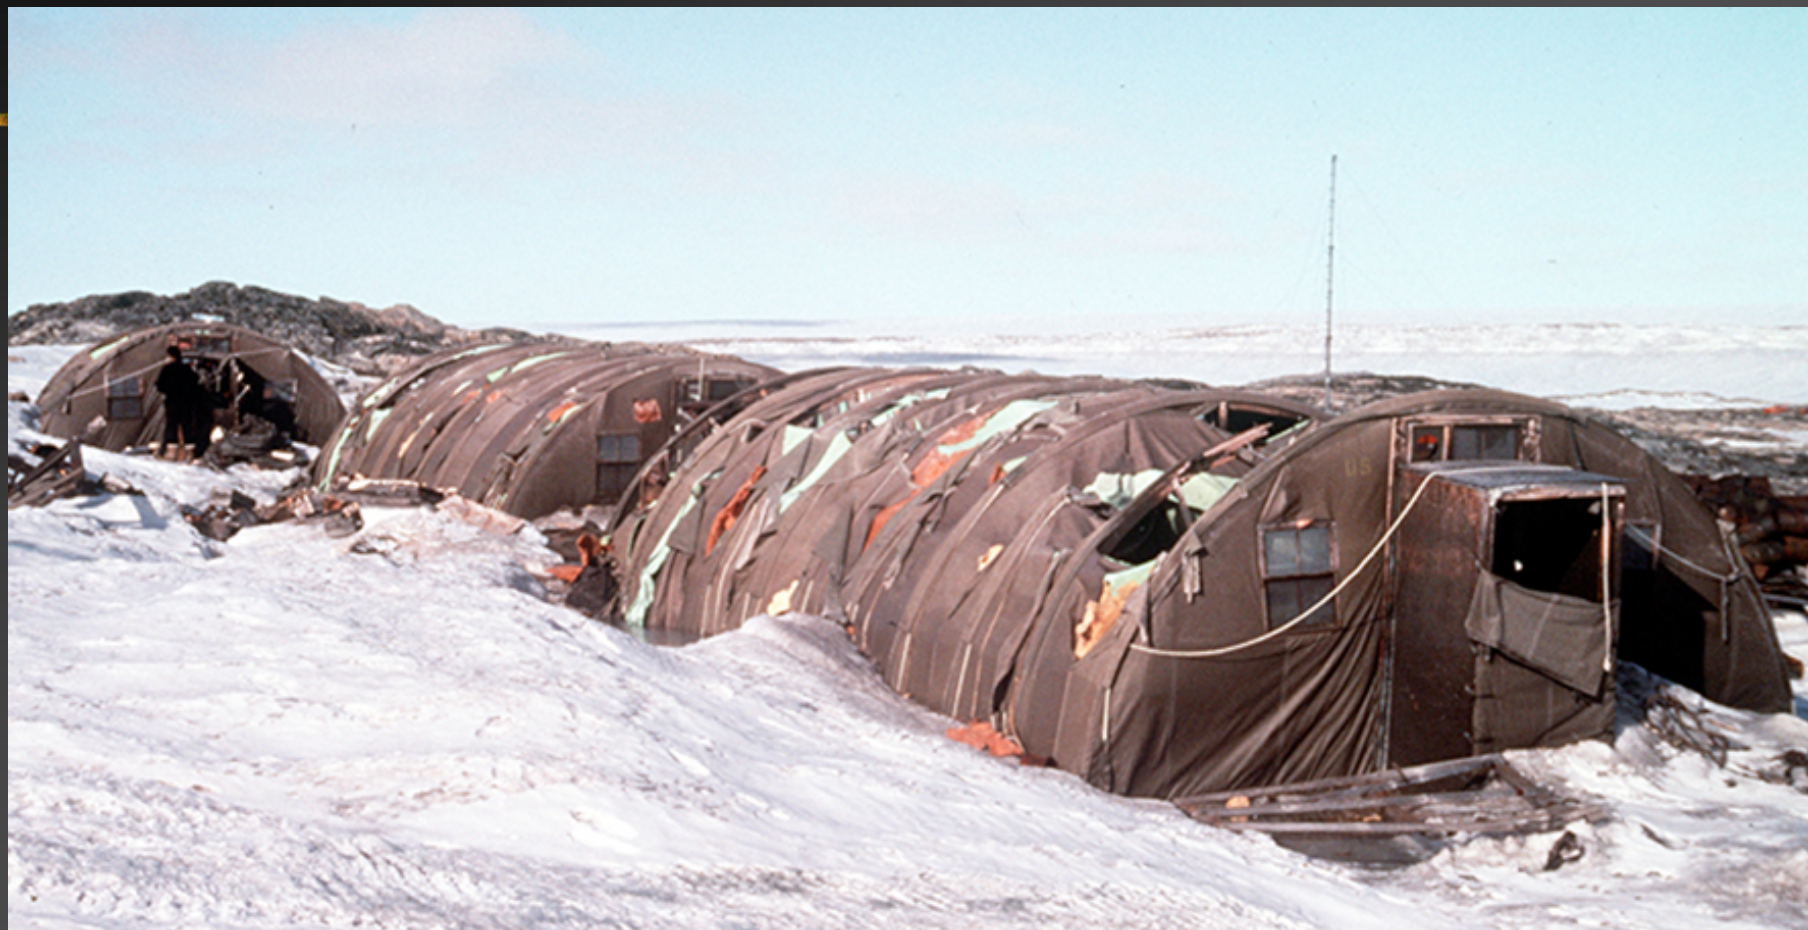
These Jamesways were initially used to house the 100 strong construction crew.

Later these buildings housed stores. While these photos were taken in 1992 even less of these double thickness canvas structures with fibreglass insulation remains in 2001.

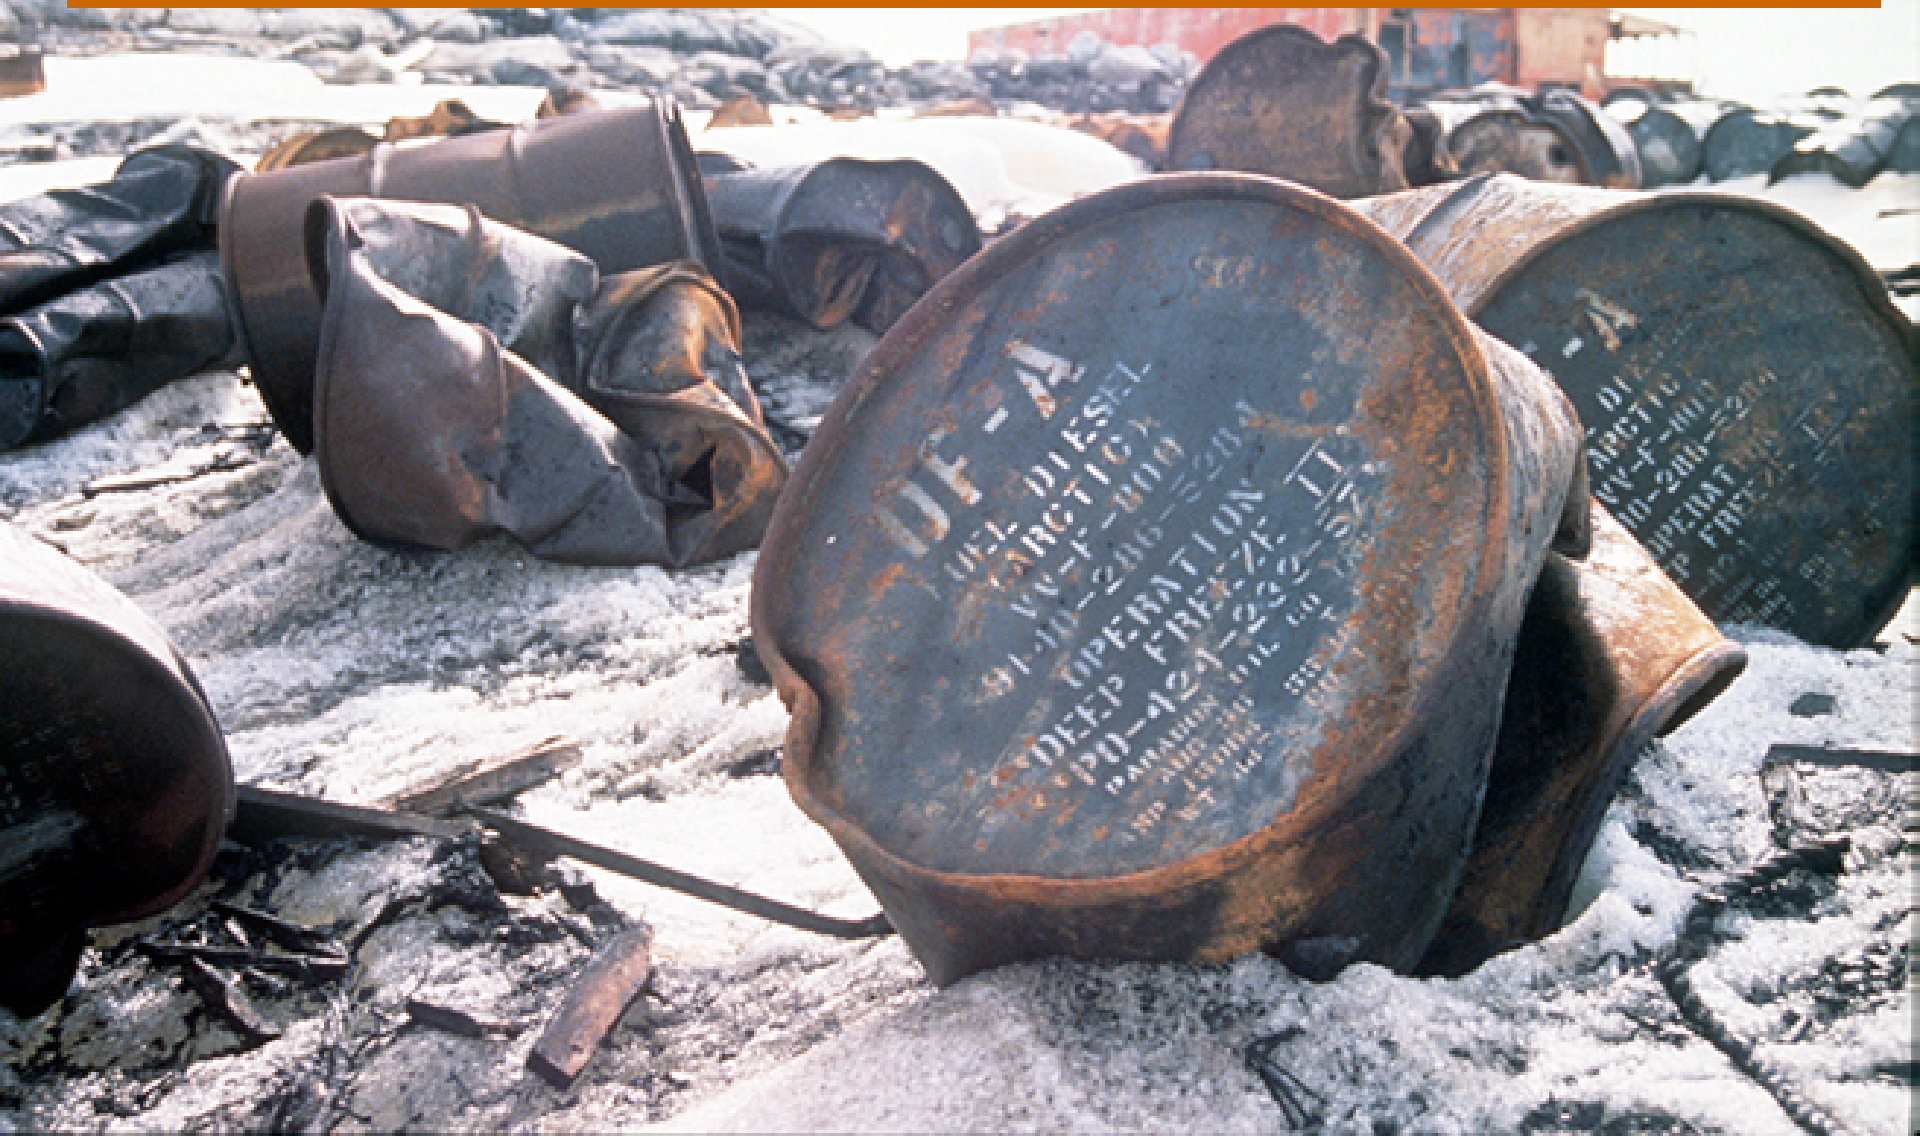
Rubbish and a corrosion test.

The details on the end of this drum identify it as being from 1957 Deep Freeze II.
